LOT 379, HIWAN FIFTH FILING, PHASE 1,  
COUNTY OF JEFFERSON, STATE OF COLORADO.  
ALSO KNOWN AS 2334 EL DORADO LN

### IMPROVEMENT LOCATION CERTIFICATE

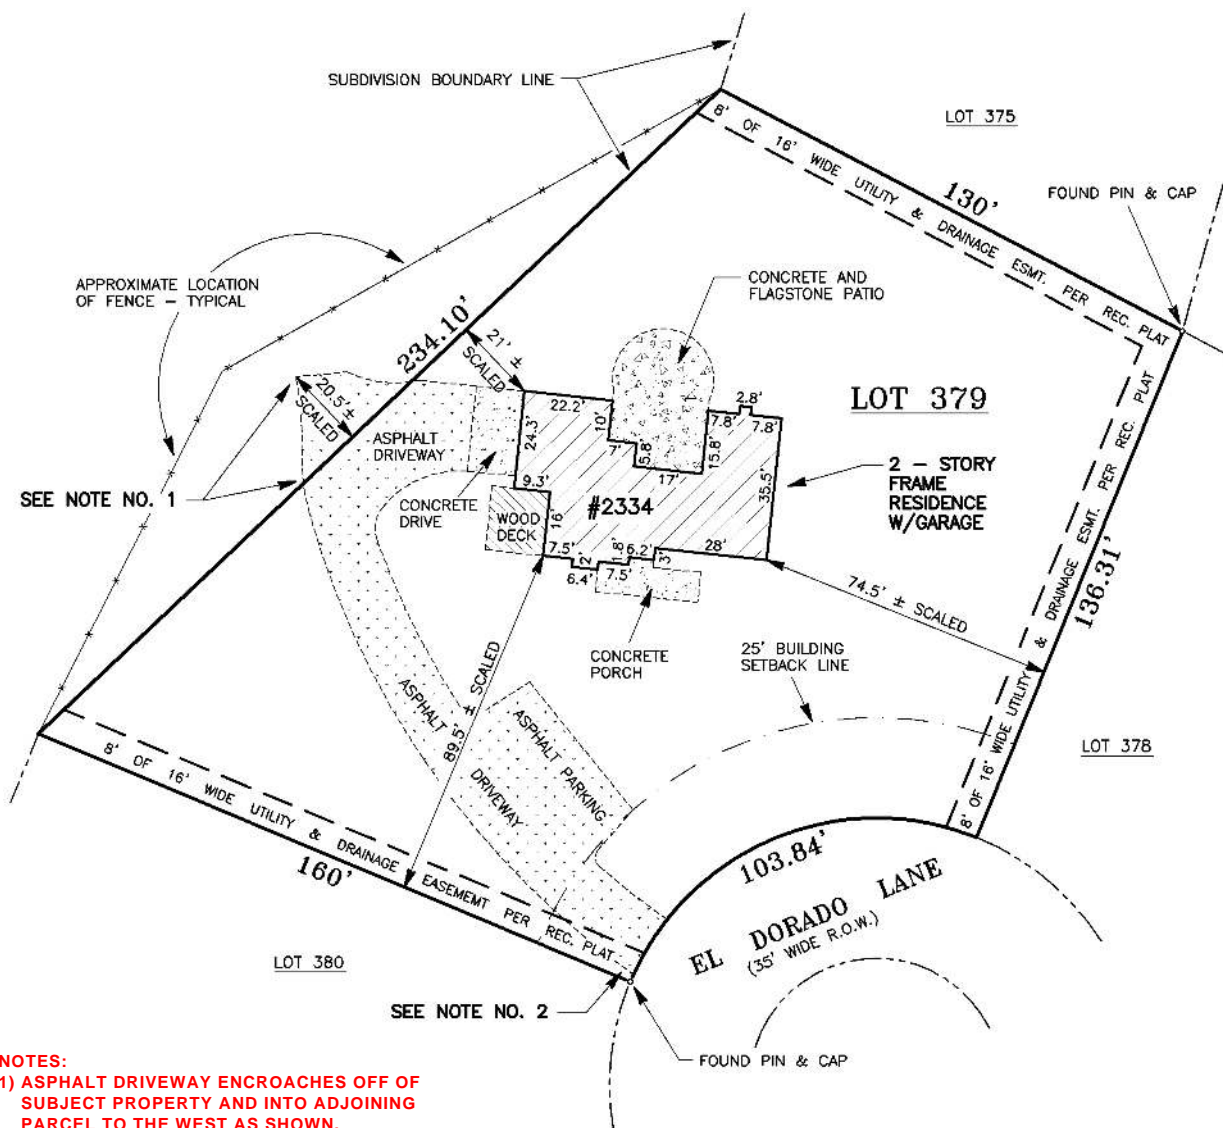
- 1) ASPHALT DRIVEWAY ENCROACHES OFF OF SUBJECT PROPERTY AND INTO ADJOINING PARCEL TO THE WEST AS SHOWN.
- 2) ASPHALT DRIVEWAY ENCROACHES INTO 8' WIDE EASEMENT BY 6' +/- AS SHOWN.
